**Second  
International Conference  
on  
Case Histories in  
Geotechnical Engineering**

**June 1-5, 1988**

**University of Missouri-Rolla  
Rolla, Missouri**

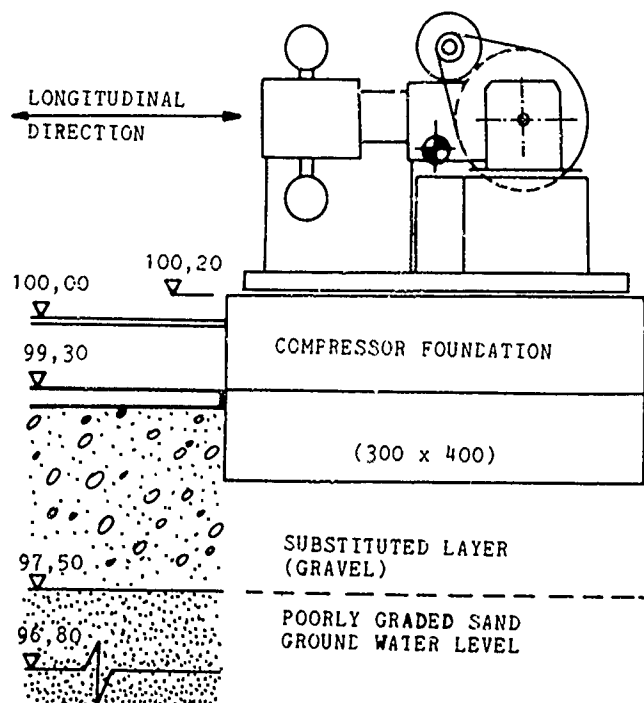
Figure 2. Cross-section of a foundation and soil in C.S.Legrad

Soil characteristics were determined by geotechnical investigations and geophysical measurements (Fig.2).

Upper two meters of poor characteristics were substituted with gravel layer. Shear wave velocity ( $V_s$ ) of sand was measured by surface refraction method; range of  $V_s$  was from 220 to 250 m/s, what correspond to values of shear modulus of 100 MN/m<sup>2</sup>.

Dominant unbalanced inertia forces act in longitudinal direction (Fig.2). According to the manufacturer of compressors the foundations must be designed to resist the following forces (dynamic loads):

Compressor foundations were designed as massive concrete blocks (Fig.2) separated 1,0 m from each other. Mass of one compressor and foundation was 46,3 t. Schematic presentation of foundation layout is in the Fig.3.

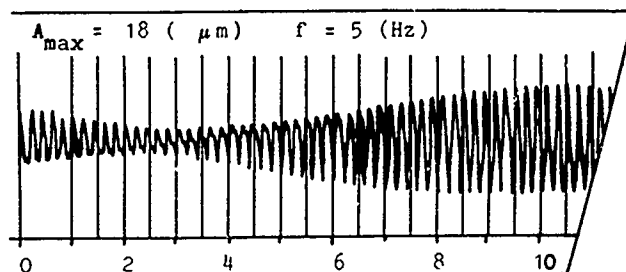
Figure 4. Longitudinal vibrations of compressor C-203

Typical plot of measured vibrations is shown on Fig.4.

The intensity of amplitudes changed periodically showing low frequency "superior" influence. Anyhow, the average amplitude (cca  $20 \mu\text{m}$  for type C-100) corresponded well to predicted amplitudes using the model with best estimate of soil properties. The rest between 20 and  $30 \mu\text{m}$  is attributed to the influence of neighbouring compressors or unbalanced secondary forces.

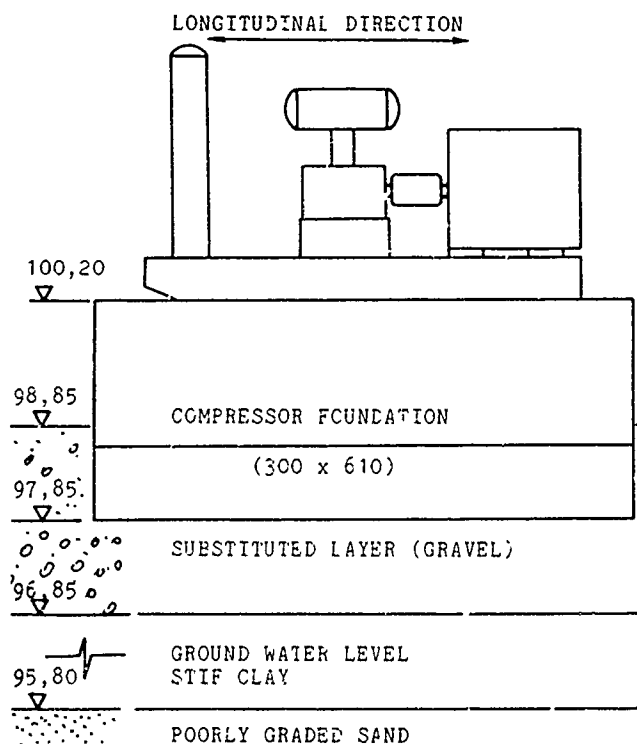
Figure 5. Cross-section of soil and foundation in C.S. Bokšić

Since the radial amplitudes were considered to be high and since there was not confidence in clay as direct foundation supporting soil, it was decided to substitute the clay above ground water level with one meter thick densified gravel layer. The gravel and the rest of the clay layer were separated with dense geotextile. The shear modulus of gravel was assumed as  $G = 100 \text{ MN/m}^2$ .

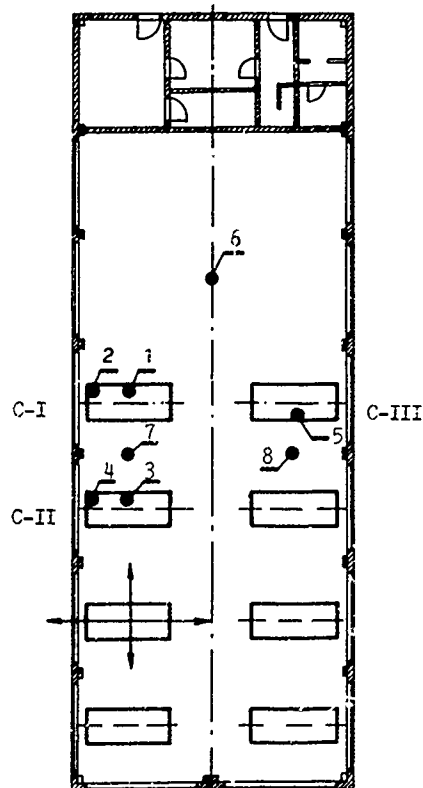
Figure 6. Layout of compressors in C.S. Bokšić

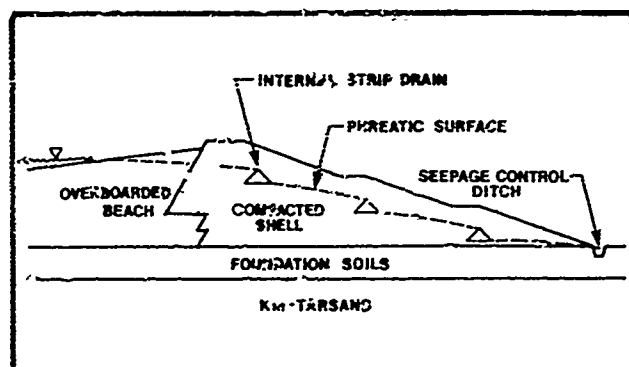
Fig. 3 Typical Design Section of Tailings Dyke

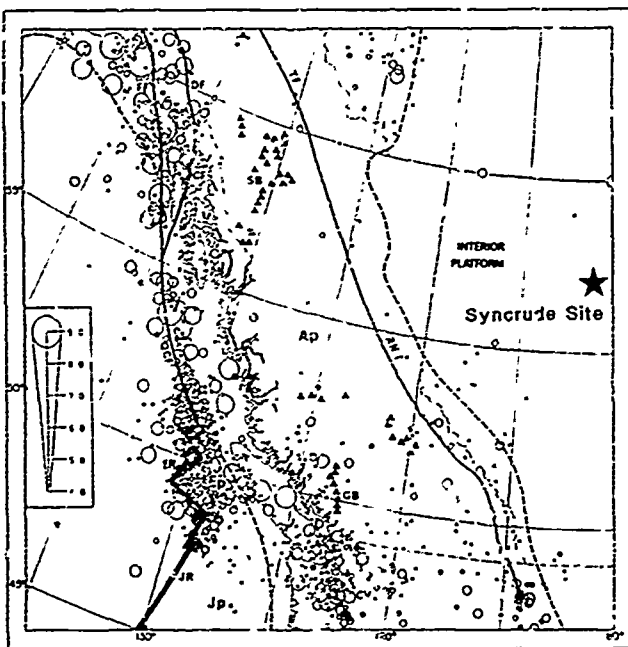
Fig. 5 Western Canada Seismicity Map and Tectonic Features (After Milne et al. 1978)

Data on seismic events affecting the Syncrude Site that occurred between 1899 and 1985 were obtained from the Pacific Geoscience Centre. Figure 5 (Milne et al. 1978) shows western Canada regional distribution of earthquakes with magnitude greater than or equal to three, updated to 1985 for the Syncrude Site. Figure 6 from the same paper, shows the pattern of strain release over the time period of 1899 to 1975 for western Canada. Strain release is calculated as the square root of the total observed seismic energy released during an earthquake. The strain release contours shown in the figure have been smoothed regionally and normalized to be the equivalent number of magnitude 5 earthquakes for an area of 100 km x 100 km and a time of 100 years.

Figure 5 also shows the tectonic features of western Canada. As shown in the figure, the most active earthquake areas correspond, in general, to the boundaries between the major lithospheric plates. These plate boundaries include:

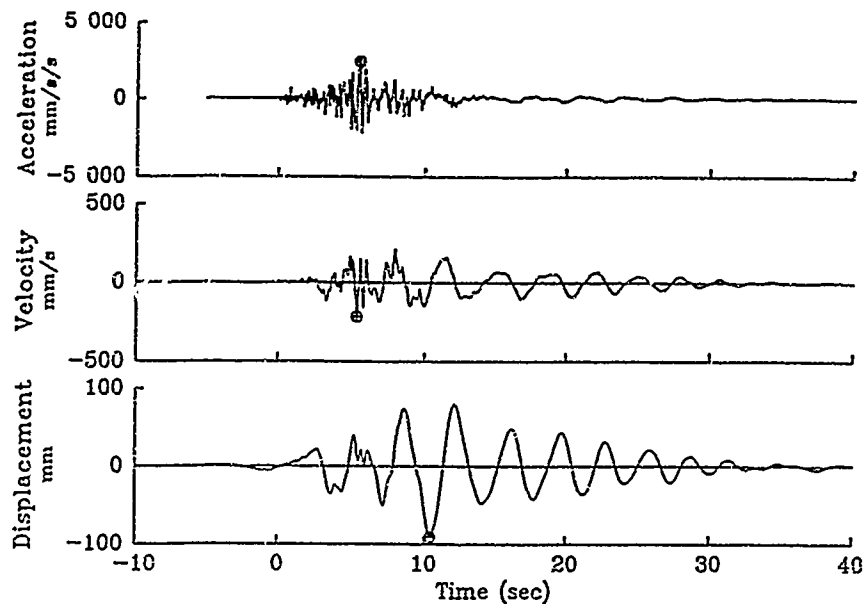
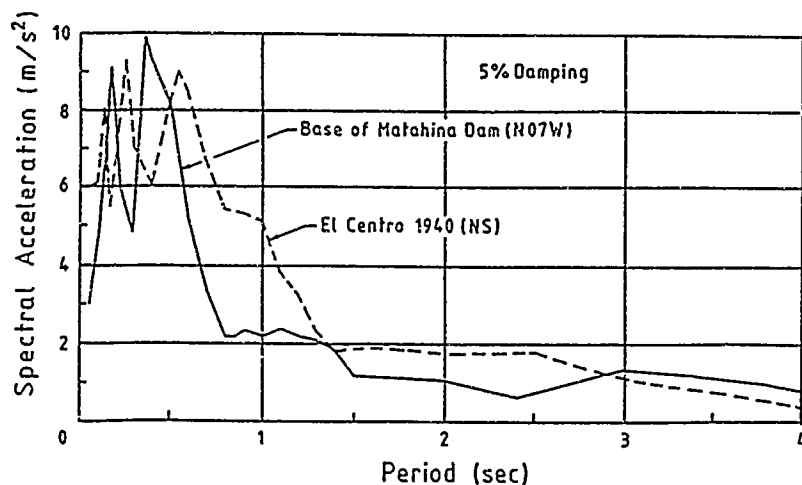
EARTHQUAKE 1987 MARCH 02 0142 UT  
 BAND-PASS FILTER TRANSITION BANDS ARE 0.100-0.250 HZ AND 24.5-25.5 HZ  
 @ Peak values: acceleration 2361 mm/s/s, velocity -216.5 mm/s, displacement -90.56 mm

Figure 3. Acceleration, velocity and displacement at the base of the Matahina Dam and comparison of the 5% damped acceleration response spectra there with El Centro 1940 (NS).

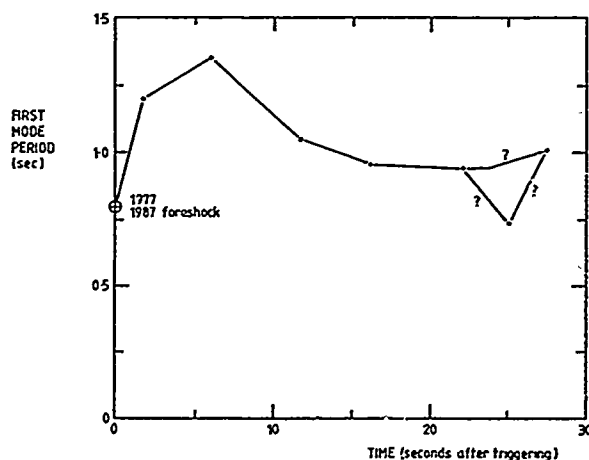
Figure 8. Variation of transverse first mode period during the mainshock (McVerry, 1987)

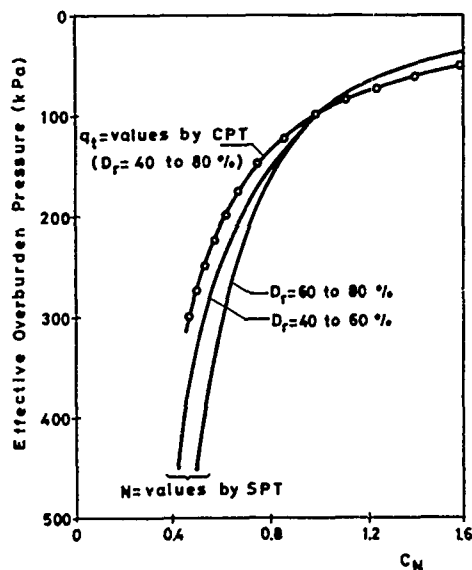
Fig. 5 Recommended Curves for Determination of  $C_N$  (after Seed et al., 1983)

where  $C_N$  = a function of the effective overburden pressure at the depth where the penetration test was conducted. The values of  $C_N$  are shown in Fig. 5.

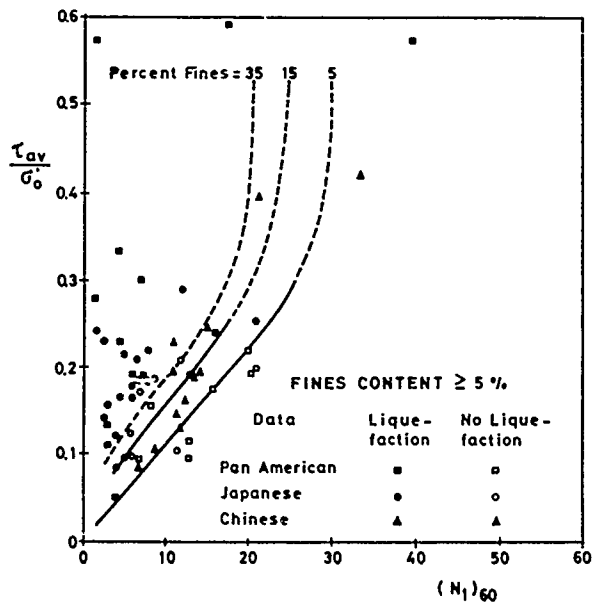
Fig. 6 Relationship between Stress Ratios Causing Liquefaction and  $N_1$  - Values for Silty Sands for  $M = 7, 1/2$  Earthquakes (after Seed et al., 1985)

From liquefaction studies performed from data of sites located in China, Guatemala, Argentina, Japan and U.S.A. Seed et al. (1985) have proposed a boundary line (or zone) separating sites known to have liquefied from sites which have apparently not liquefied in earthquakes of magnitude about 7 - 1/2 for sands and silty sands (Fig. 6). These results are also extended to other magnitude events (Seed et al., 1983).

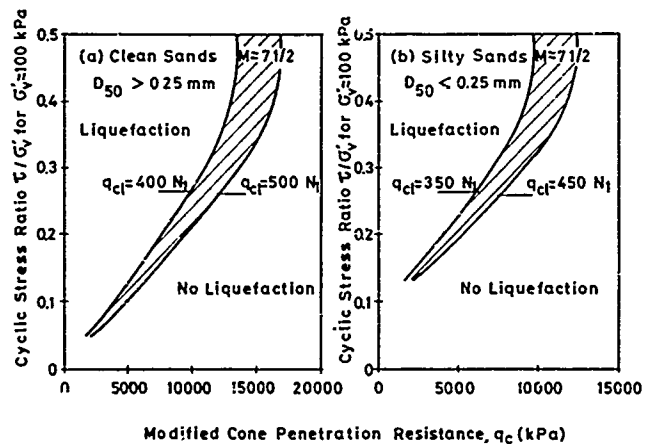
Fig. 7 Proposed Correlation between Liquefaction Resistance of Sands for Level Ground Conditions and Cone Penetration Resistance (adopted from Seed et al., 1983)

Using the relationships  $q_{c1}$  (Kpa) = 400 to 500  $N_1$  for clean sands and  $q_{c1}$  (Kpa) = 350 to 450  $N_1$  for silty sands proposed by Schmertmann (1976) the plots relating values of cyclic stress ratio causing liquefaction with  $q_{c1}$  values are shown in Fig. 7 (Seed et al., 1983).

Considering an average value of CPT = 2500 Kpa, from Fig. 7 it may be concluded that soil liquefaction can occur.

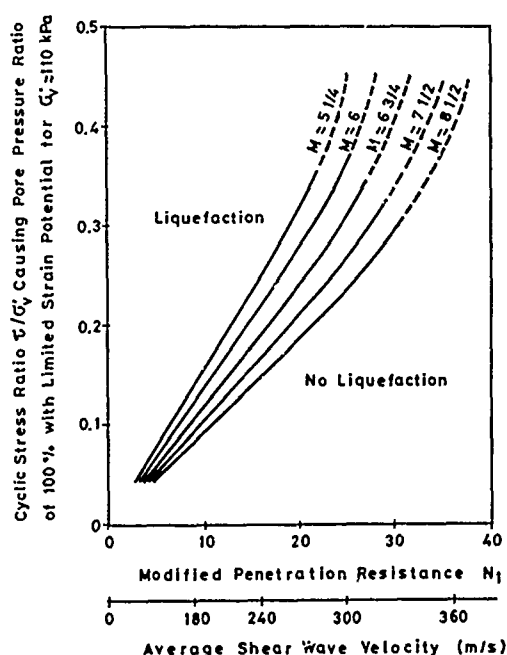
Fig. 8 Proposed Correlation between Liquefaction Resistance of Soils containing Gravels for Different Magnitude Earthquakes and Average Shear Wave Velocity (adopted from Seed et al., 1983)

for depths up to about 15 m. This relationship is shown in Fig. 8.

As the average shear wave velocity  $v_s = 170$  m/s is less than 366 m/s soil liquefaction can occur.

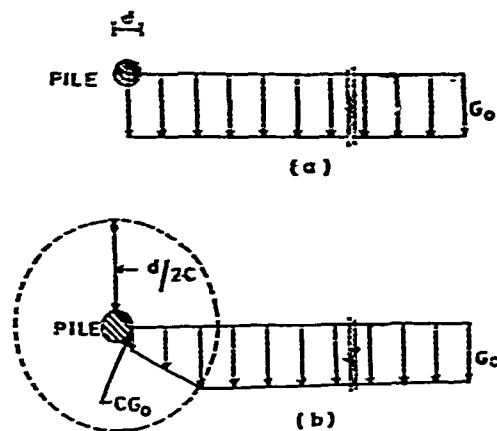
Fig.2 (a) Homogeneous Model  
(b) Non-Homogeneous Model

Fig.2 shows the two analytical models involved in the dynamic analysis based on the continuum approach:- (a) a plane strain model assuming a homogeneous variation of shear modulus in the radial direction, and (b) the non-homogeneous model earlier referred to. In the latter, the shear modulus of soil is assumed to vary linearly from a value of  $C.G_0$  (where  $C < 1$ ) at the pile-soil interface to a value  $G_0$  at a distance of  $d/2C$  where  $d$  is the diameter of the pile and  $G_0$  is maximum shear modulus in the far field. The reduced shear modulus of soil is attributed to the high shear stresses in this region, the lowest value occurring at the pile-soil boundary. This model, therefore, divides the soil stratum in the radial direction into an inner ring having variable shear modulus of the above description and the outer medium which extends to infinity and possesses uniform visco-elastic soil properties.

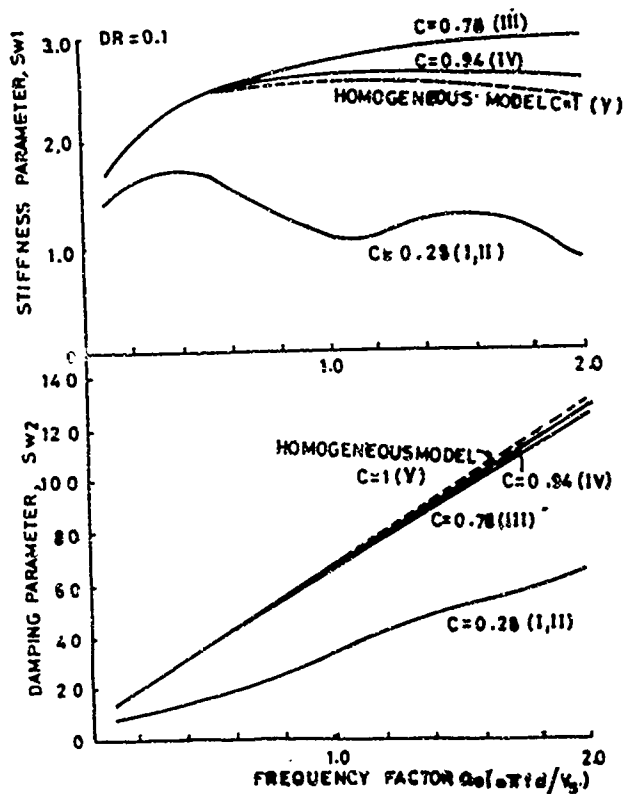
Fig. 9 Variation of  $Sw_1$  &  $Sw_2$  with  $a_0$   
(Non-Homogeneous Model)

The modified values of  $S w_1$ ,  $S w_2$  etc., are now used in place of the corresponding values derived from the PILAY program (SACDA, 1981) which is applicable for the plane strain case in a homogeneous soil medium. The PILAY program then yields the net stiffness and damping values of the pile-soil system for the non-homogeneous soil model earlier referred to.

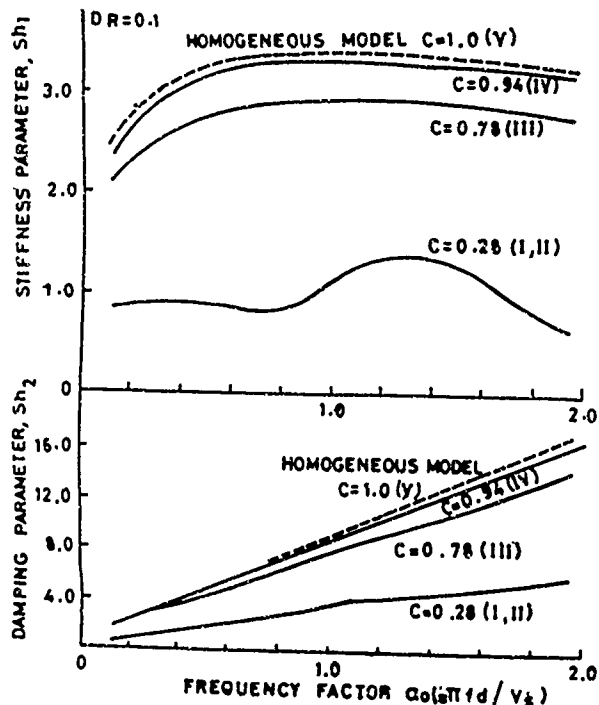
Fig. 9 Variation of  $Sh_1$  &  $Sh_2$  with  $a_0$   
(Non-Homogeneous Model)

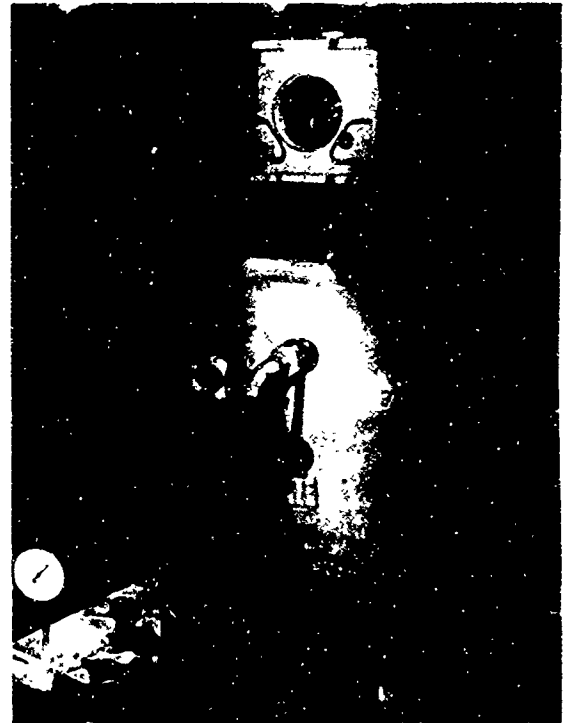
Fig. 10 Close View of the Static Test Set-up

Fig.10 shows the static test set up used for loading the pile in the range of 0 to 100 tonnes. The load is incremented in stages and the average elastic deflection recorded by the dial gauges is noted after successive loading and unloading cycles. Fig.11 shows the variation of elastic deflection with the applied load as computed and as measured from the experiments. The agreement between the two sets of values is seen to be quite good, thus verifying the validity of the analytical model earlier explained.

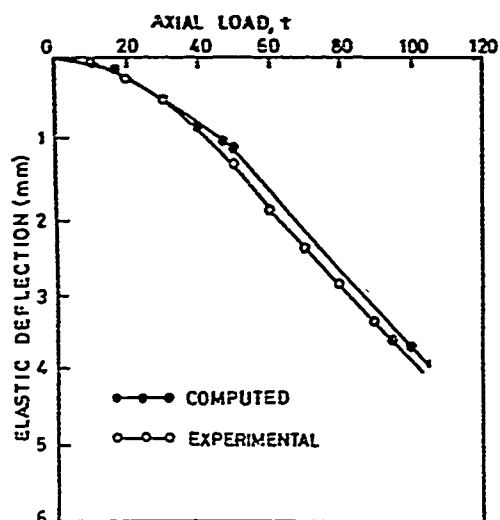
Fig. 11 Elastic Deflection Vs. Axial Load on the Test Pile

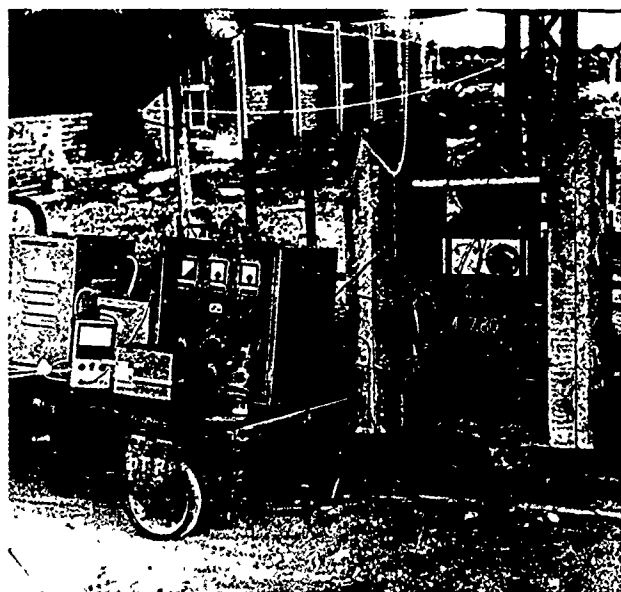
Fig. 12 Set-up for Vertical Dynamic Test

The purpose of this test programme was to verify under dynamic conditions, the validity of the radial non-homogeneous model earlier explained, using the values of  $C$  obtained from the static analysis. Vertical and horizontal dynamic tests have been conducted separately on the test pile by attaching at its top a mechanical oscillator coupled with a DC motor which induces steady state oscillations in the pile. Figs.12 & 13 show the test set up showing the pile under vertical and horizontal vibrations respectively.

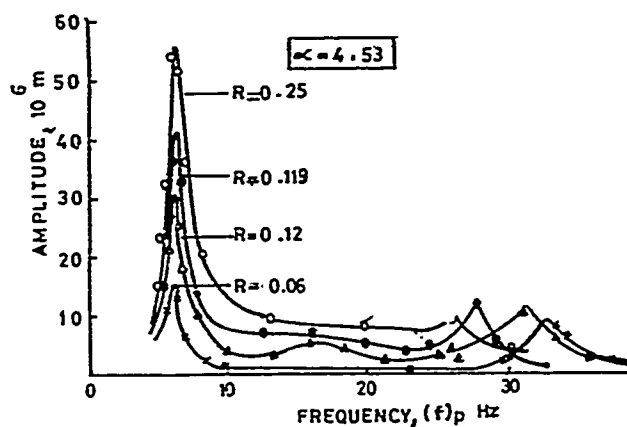
Fig. 15 Typical Pile Response (Horizontal Dynamic Test)

a parameter which defines the dynamic force ( $F_d$ ) given by the relation  $F_d = Rf^2$ ,  $f$  being the frequency of excitation. Fig.14 & 15 show typical response plots obtained from the dynamic tests corresponding to one value of  $\alpha = 4.53$  and for varying values of  $R$ . The resonant frequencies are identified by the peaks of the response curves. Tables 2 & 3 show comparison of natural frequencies deduced from the theoretical models and experimental data. It is seen from Table 2 that there is no significant difference in the analytically deduced vertical frequencies using  $C = 1$  (homogeneous mode I) and using variable values of  $C$  (non-homogeneous model) obtained from the static analysis. This may be attributed to the marginal contribution of the soil layers having low values of  $C$ . However, in Table 3 which shows the horizontal frequencies, the experimental values agree more closely with the non-homogeneous model than the homogeneous model assumed in the PILAY program.

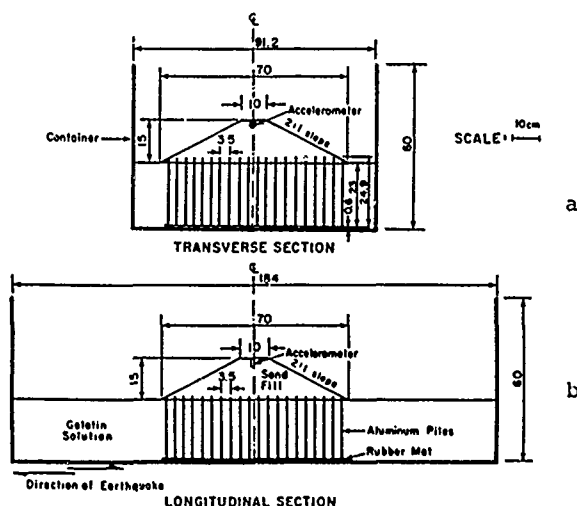
FIG. 1: Details of Model Set-Up.

The model was constructed in a plexiglass container bolted securely to the shaking table. The dimensions of the box were 1.84 m x 0.91 m x 0.6 m as indicated on Figures 1a and 1b. The soft organic foundation soil was modelled by a gelatin solution. The gelatin had a shear strength of 2.2 kPa. Such a shear strength was considered appropriate since it provided a

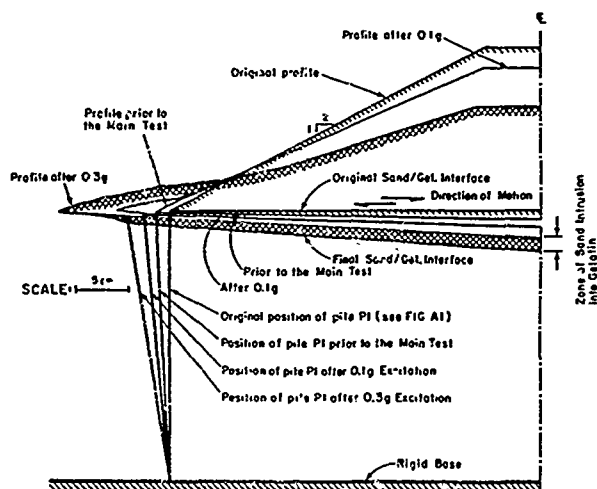
FIG. 2. Deformed Profiles at Various Stages of Shaking (Section 5-5, Fig. B1).

The sequence of movements of a section of the model prior to dynamic testing, after 10% base excitation and after 30% base excitation are depicted in Figure 2. These movements are based upon surface movement measurements, video and movie recordings, and visual observations during and after testing together with volume compatibility constraints. Details of the calculations involved are shown in Appendix C. Prior to dynamic testing, the piles at the toe of the embankment had moved outward about 1 cm due to construction of the fill. Such outward movement would induce downward movement of the sand-gel interface as shown. Crest deformation of 2 cm resulted after application of the 10% g base excitation motion. Additional outward movement of the toe piles together with movement of the gel surface occurred at the same time as shown in the Figure. The profile after 30% g is also shown in Figure 2 and indicates a crest movement in excess of 5 cm and lateral spreading of the fill of some 10 cm. The lateral movement of the pile heads at the toe of the slope was about 4.5 cm or about half the spreading movement of the

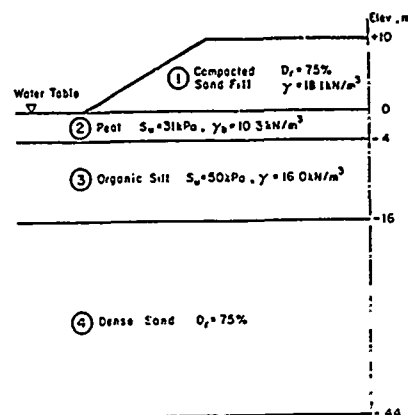
FIG. 3. Prototype Soil Profile.

Seismic deformations of the fill are therefore mainly due to deformations of the foundations caused by the transfer of vertical load from the piles to the foundation during the period of shaking. The maximum seismic deformations can be estimated for the prototype from a static finite element analysis in which all of the weight of the sand embankment is assumed to be transferred to the foundation soil during the shaking. Under these conditions the organic soil would behave in an undrained manner. Based on the soil profile and properties shown in Figure 3, a crest settlement of 0.4 m together with a horizontal longitudinal displacement of

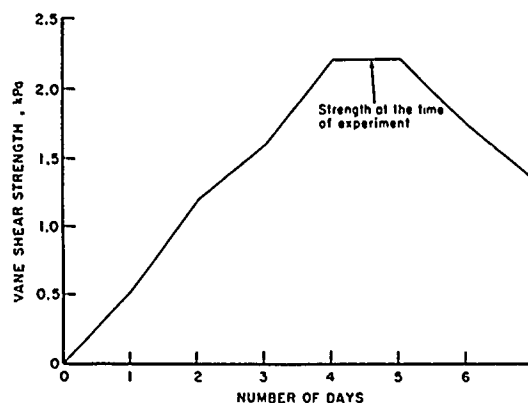
FIG. A1. Change of Shear Strength with Time for 6% Gelatin Solution Prepared at 65°C.

the change of strength with time for a gel prepared in this manner is shown on Figure A1. It can be observed that the peak strength is achieved after approximately 4 days, beyond which degradation occurs by bacteria and molds. The nature of the organisms which grow in gelatin solutions depend upon a number of factors. However, it was found that the rate of growth is significantly smaller for samples prepared at 65°C in comparison with other techniques of dissolving the gelatin crystals. Extreme care was exercised to ensure that the crystals were thoroughly dissolved before removing the foam and pouring the solution into the container. The solutions were prepared in 30 litre batches and the total amount (approximately 400 litres) was poured in place within 2.0 hours. Using a miniature vane device, the shear strength of the gel at the time of the experiment was measured to be 2.2 kPa. Such a shear strength was considered to be appropriate since it provided a reasonable factor of safety against a bearing capacity failure upon the placement of the sand fill as well as leaving some margin of safety for possible weakening of the gel peak strength prior to the experiment. The Young's modulus of the material was approximately 10 kPa and was determined by measuring the depression due to a uniform load applied to the gel's surface.

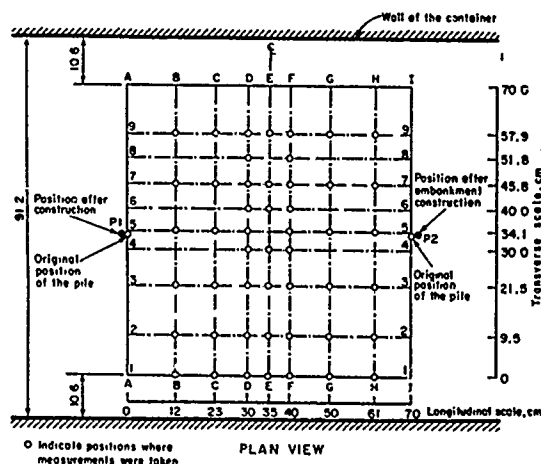
FIG. B1. Location of the Points Where Movements were Monitored.

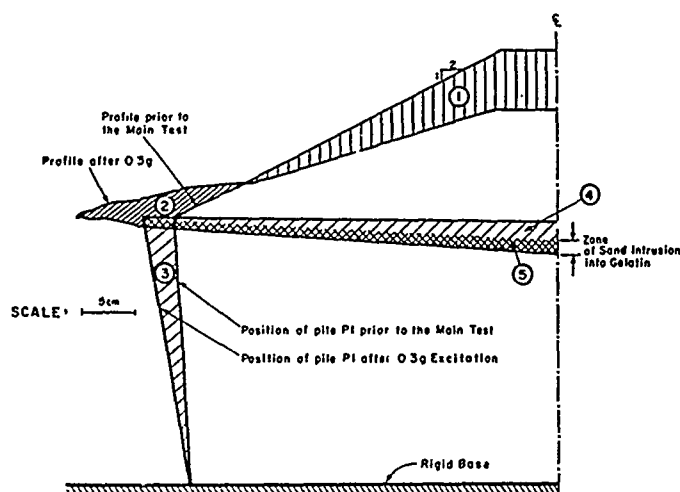
FIG. C1. Deformed Sand-Gel Interface Based on Volume Compatibility.

Based on observation and the measurements taken, the surface profile of the fill was determined. Knowing the deflection of the piles, and assuming that the piles and gelatin move together, the lateral component of the movements was obtained. If it is assumed that there is no change in the overall volume of the sand fill, analysis based on compatibility of volumes can be performed to establish the deformation profile at the base of the embankment. Such analysis require a trial and error balancing of areas. The estimated base profile at the end of the shaking (after 0.3 g) is shown in Figure C1. The areas involved were as follows:

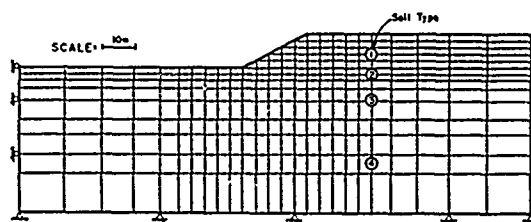
FIG. D2. Finite Element Mesh Used.

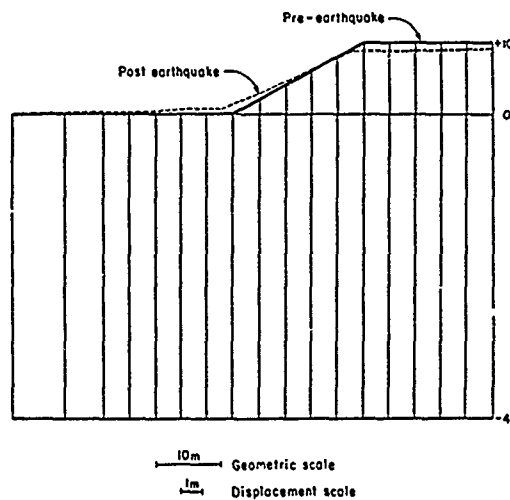
FIG. D3. Post Earthquake Deformation of Prototype.

The earthquake induced displacements were computed using the finite element method and assuming that all of the fill load must be carried by the foundation soil. The computer program SOILSTRESS (Byrne and Janzen, 1981) which performs an equivalent linear elastic analysis was used. The finite element mesh is shown in Figure D2. The computed displacement pattern is shown in Figure D3. It may be seen that the crest of the embankment settles about 0.4 m and also moves out horizontally about 0.4 m. Some heave is predicted to occur in the toe area.

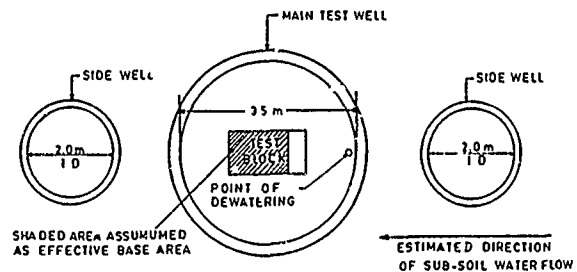
Fig. 1 - Plan of Test Arrangement

constructed in a brick well of 3.5 m internal diameter at the proposed foundation depth. Two side wells of 2 m internal diameter were also constructed (Fig. 1).

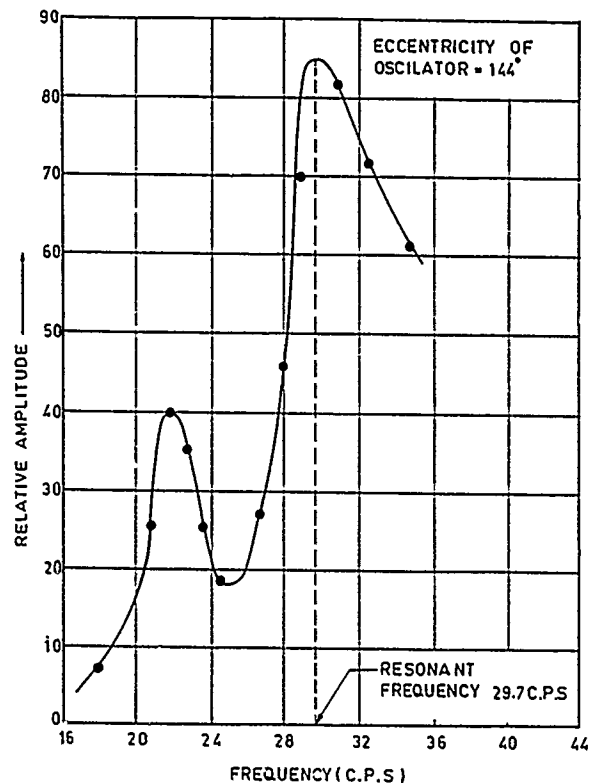
Fig. 3 - A Typical Amplitude v/s Frequency curve from Vertical Resonance Test

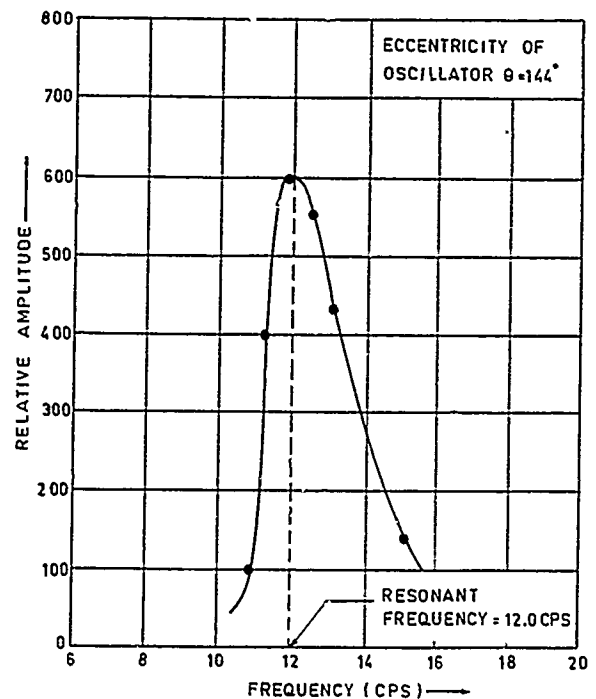
Fig. 4 - A Typical Amplitude v/s Frequency Curve from Horizontal Resonance Test

When an oscillator is mounted on the top of the block to produce horizontal excitation, such an excitation causes the block to vibrate in coupled translatory motion along the longitudinal axis and rocking motion about transverse axis of the block. Thus the system has two degrees of freedom and hence two natural frequencies and also two resonant frequencies. In order to determine whether the resonant frequency obtained is corresponding to first or second mode of vibration, the amplitudes were observed carefully for different frequencies of the oscillator which varied from 0 to about 30 c.p.s. in one case. It was observed that first resonance occurred near 12 c.p.s. The amplitudes were at the lowest at 24 c.p.s. and started

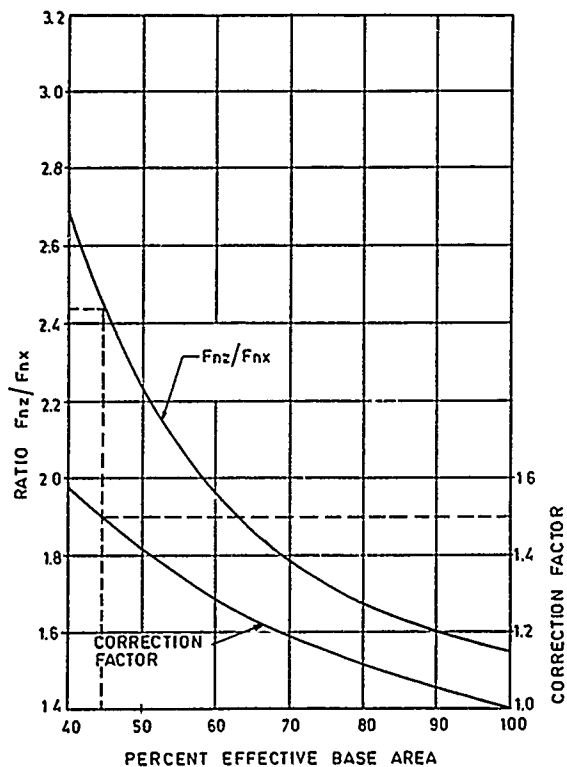
Fig. 5 - Ratio of Frequencies ( $f_{nz}/f_{nx}$ ) & Correction Factor v/s Effective Base Area Curves

Using equation (9),  $f_{nz}/f_{nx}$  v/s per cent effective base area curve has been drawn in fig. 5. Correction factor v/s per cent effective base area has been derived using equation (2) and plotted in fig. 5.

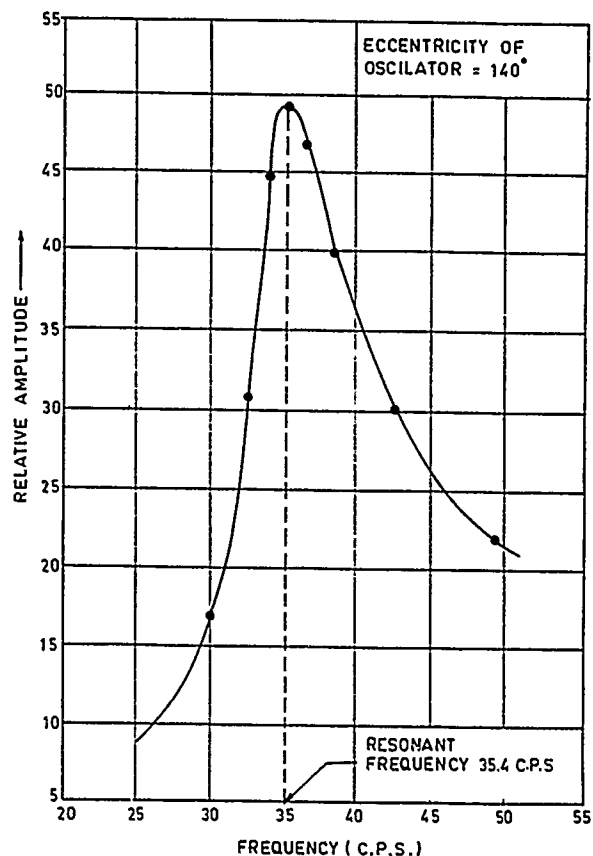
Fig. 6 - A Typical Amplitude v/s Frequency Curve from Vertical Resonance (Repeat) Test

vertical resonance test is shown in fig. 6. The results are shown in tables 3 & 4.

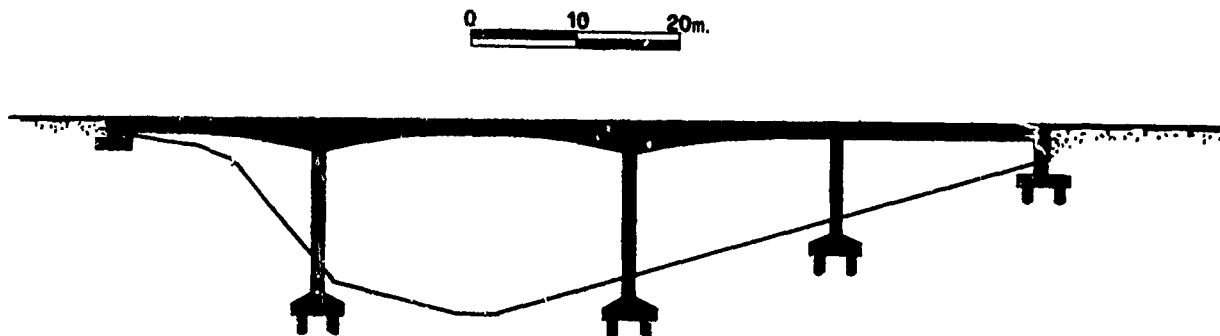
Fig. 2. Schematic Bridge's Section

Five "borehole shear tests" have been conducted on the sides on which the bridge's piers will be located (Fig. 2).

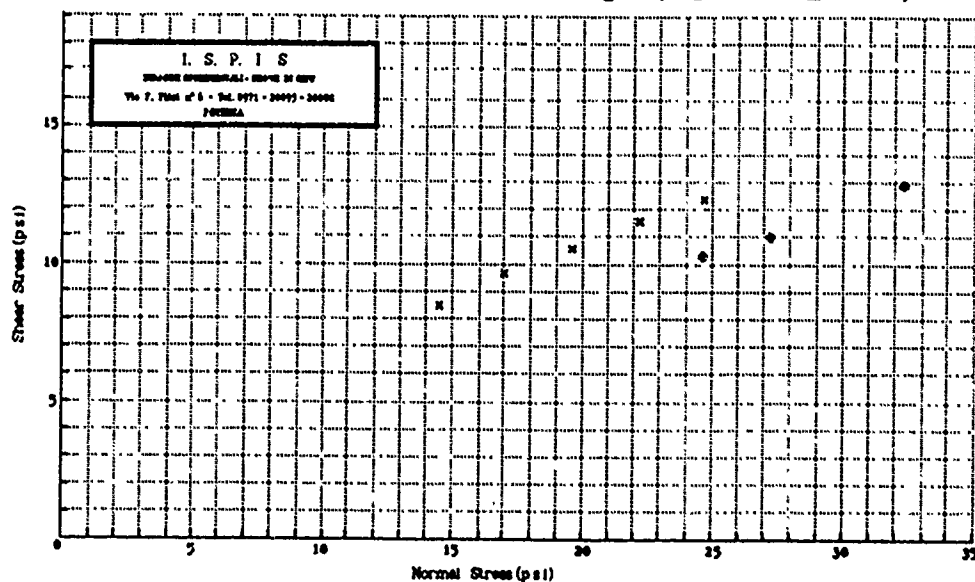
Fig. 3. B.S.T.'s 1 and 1'

For each point a series of tests with increasing applied normal stress ( $\sigma$ ) was performed, while the corresponding shear stress ( $\tau$ ) was measured. The consolidation time, before increasing normal stress, was evaluated by monitoring the dissipation of excess pore pressures generated after application of the normal stress. Shearing strength was then plotted versus normal stress to give a Mohr-Coulomb type failure envelope.
